## Permanent Aviation Fuel Facility (EP-262/2007/B)

Marine Archaeological Watching Brief Report

6<sup>th</sup> May 2008

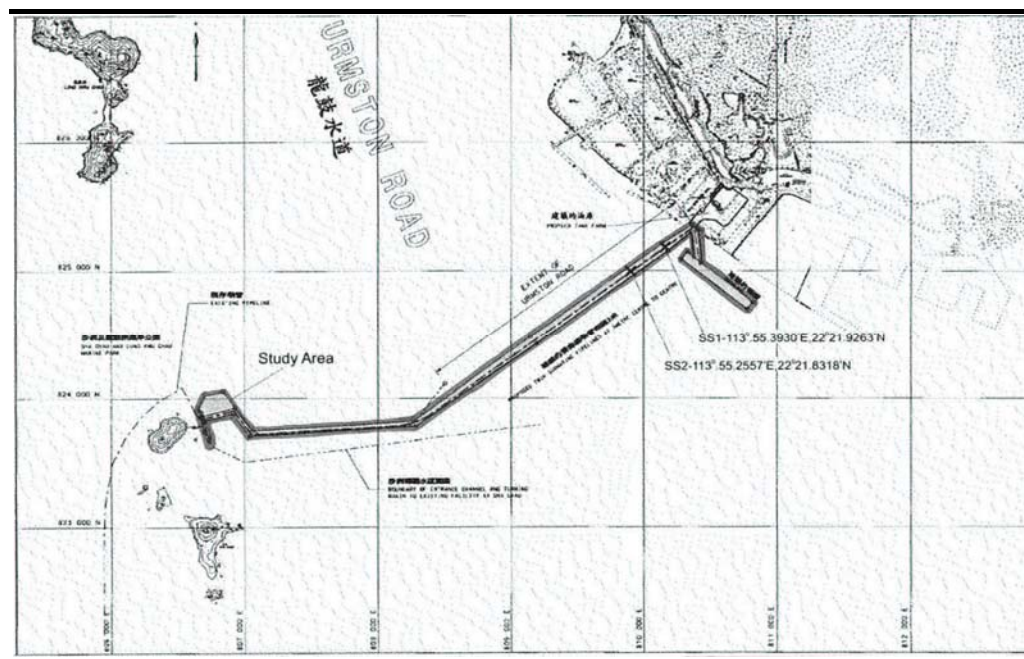
**Figure 1.1** Location of the PAFF Submarine Pipelines Route and Anomalies SS1 and SS2

It was recommended in *Section 9.8* of the EIA report and *Section 9.2* of the EM&A that a marine archaeological watching brief be instigated during dredging within 25m either side SS1 and SS2 and a dive survey be undertaken in the nominated area SS1 after 3m of sediment removal and after 1m for SS2 to examine the trench for possible cultural remains (see *Figure 1.1*).

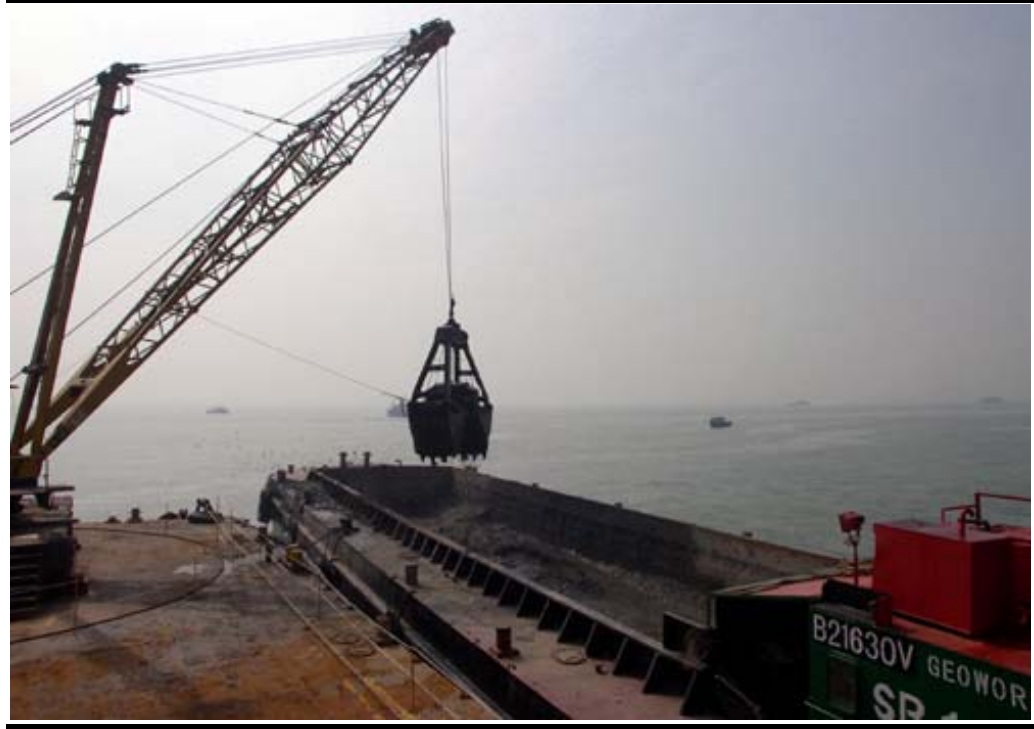
*Figure 3.1 The Bucket Dredge*

A bucket or grab dredge, capable of dredging a 20-metre wide trench was used to remove seabed sediments to the level of the sub-surface anomalies (see *Figure 3.1*). Located at the top of the crane used to raise and lower the bucket is a DGPS aerial which is directly above the dredge bucket; the readout is in the cabin with the dredge operator. This allows for accurate positioning of the trench (see *Figure 3.2*). The computer program displaying the DGPS

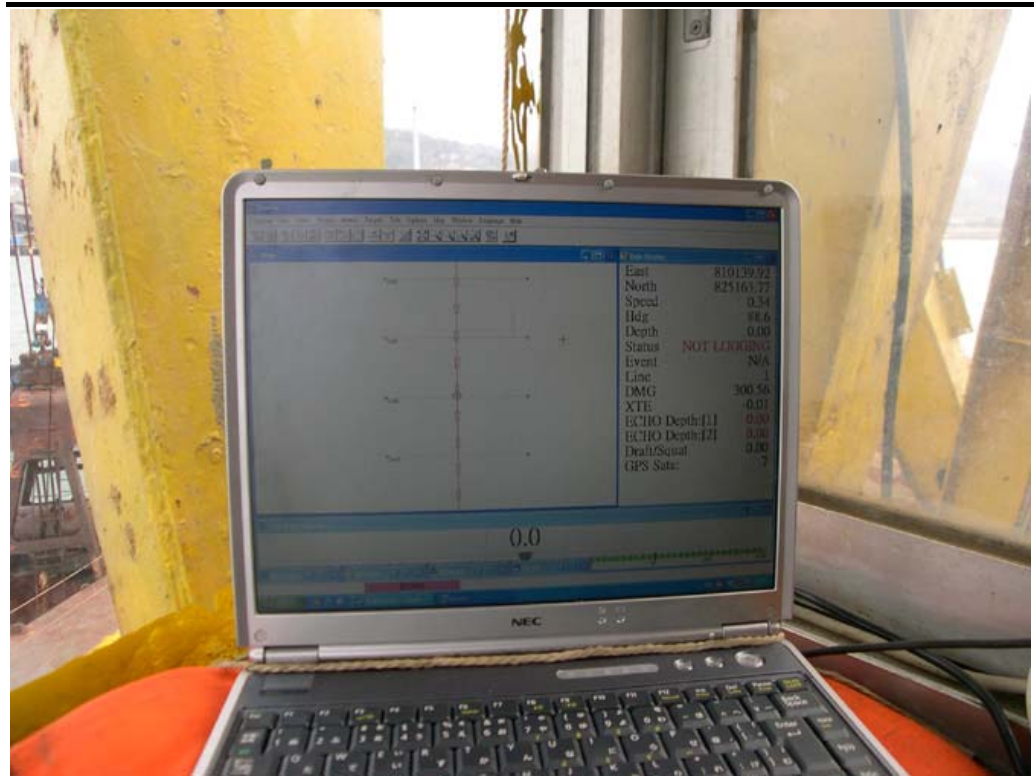
*Figure 3.2 The DGPS Readout as seen by the Dredge Operator*

coordinates also displays the position of the bucket when dredging the seabed and provides an offset value to the centreline of the trench. The cables that are used to lower and raise the dredge bucket are marked every metre to assist the operator in achieving the correct depth of penetration into the seabed of the bucket.

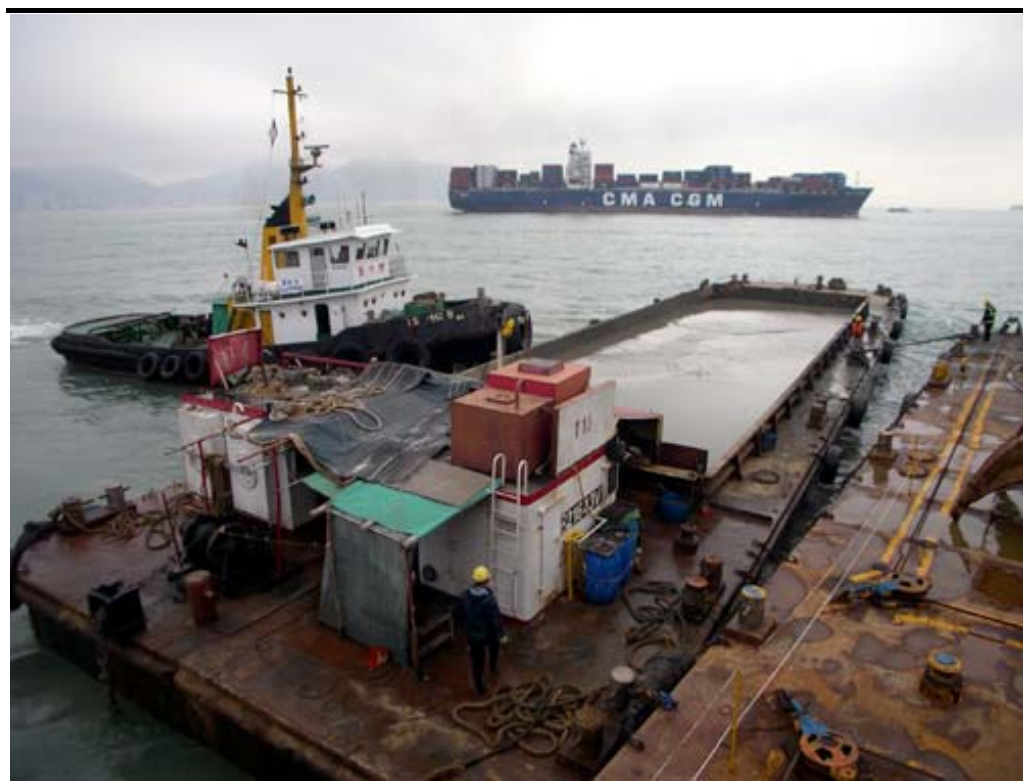
**Figure 3.3**     *The Split Hopper Barge and Tug Boat*

The dredging barge is fixed in position by four large anchors. It is positioned at one end of the trench to be dug and winches onboard move it forward along the anchor wires at 2-3 metre increments. The dredged sediments (the bucket used in this case had a capacity of 6.5 m<sup>3</sup> and weighs 12 ton) are deposited in a split hopper barge positioned next to the dredging barge, of which the capacity is about 700m<sup>3</sup>. The split hopper barge is towed by a tug to the designated mud disposal areas for uncontaminated and contaminated mud (south of Cheung Chau/east of Ninepin and East Sha Chau respectively). (see Figure 3.3).

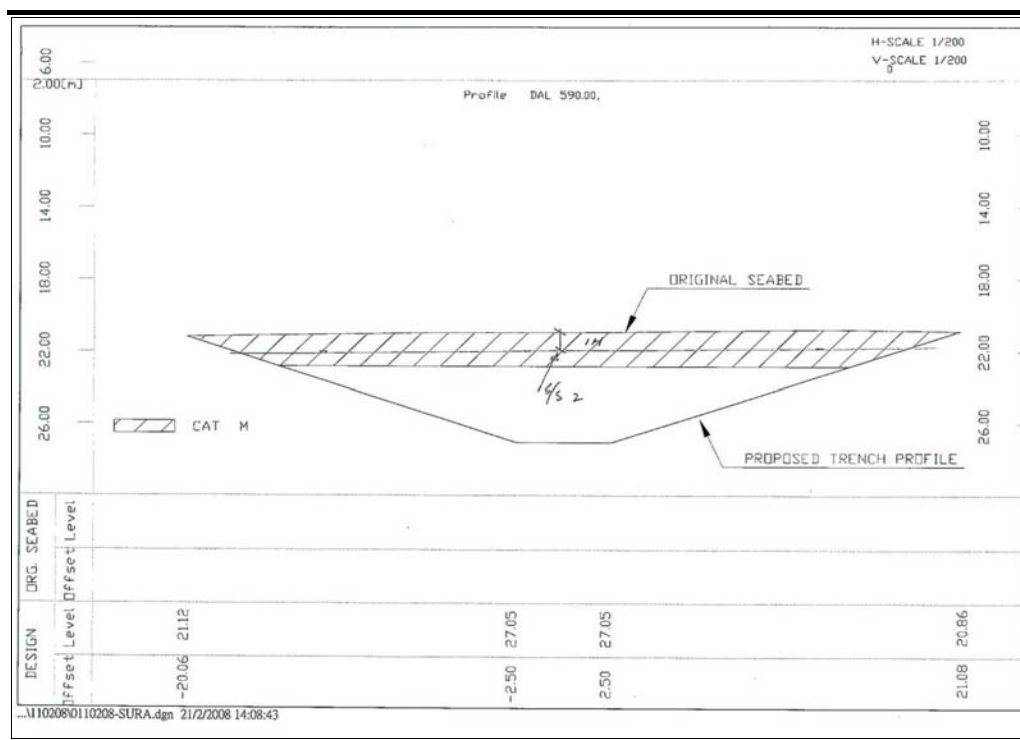
Figure 3.6 Cross Section of the Trench at SS2

At SS2, the planned depth of the pipelines is to be about 6 metres and providing for the most appropriate gradient of the trench walls, the area to be dredged is about 20 metres to the north and 20 metres to the south of SS2 (see Figure 3.6). Two, 20-metre wide trenches were therefore required to be dredged to the depth of the anomaly of one metre. This area was between 565 metres and 615 metres from the seawall at the Tuen Mun Area 38 and amounted to 2,000 m<sup>3</sup> of sediment (see Figure 3.5). It was computed that the dredging would take about 12 hours to dredge and dump these sediments.

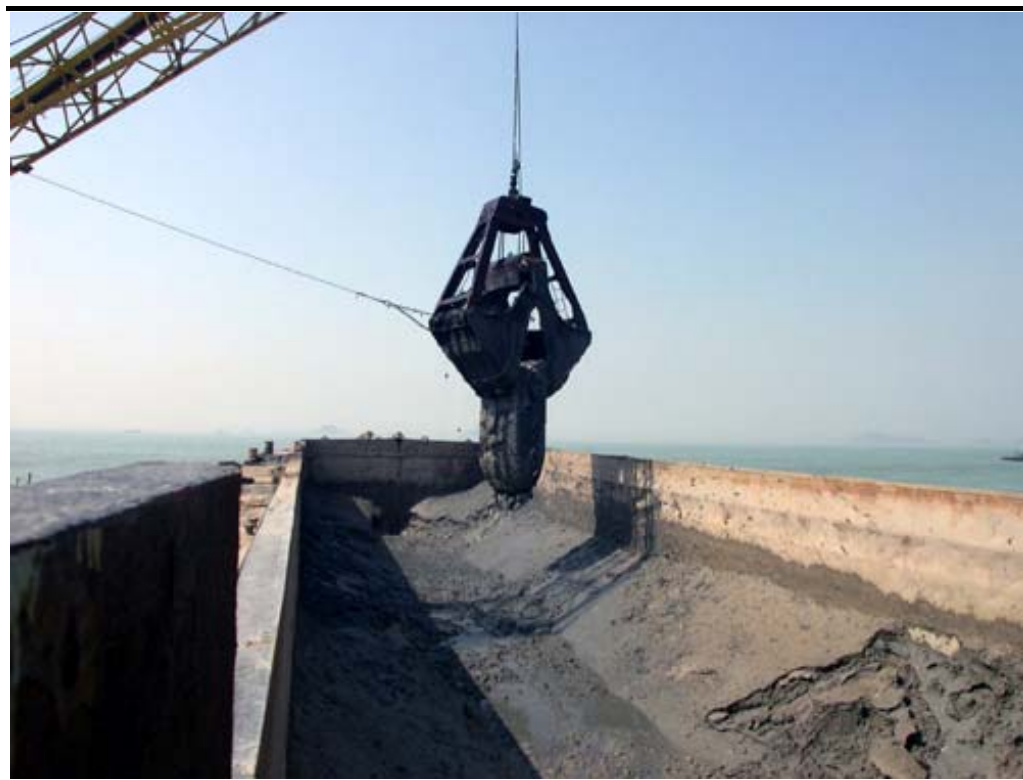
*Figure 3.7 Dredge Bucket Dropping Sediment into the Barge*

In discussion with the Dredging Supervisor, it was concluded that the dredge operators would most likely not 'feel or hear' fragile material such as timber when grabbing the sediments with the bucket and only hard and dense material may be discerned. This meant that material had to be grabbed and brought up to be dumped in the split hopper barge for any archaeological assessment to be made. The process of dumping sediments in the barge also meant that heavy material would quickly sink to the bottom of the barge (about 4 metres deep), with a possibility that more positive buoyant material (timber) may initial remain on the top of the sediments (see Figure 3.7). Waterlogged timber from a shipwreck for instance would, however, most likely sink or be quickly covered with sediment.

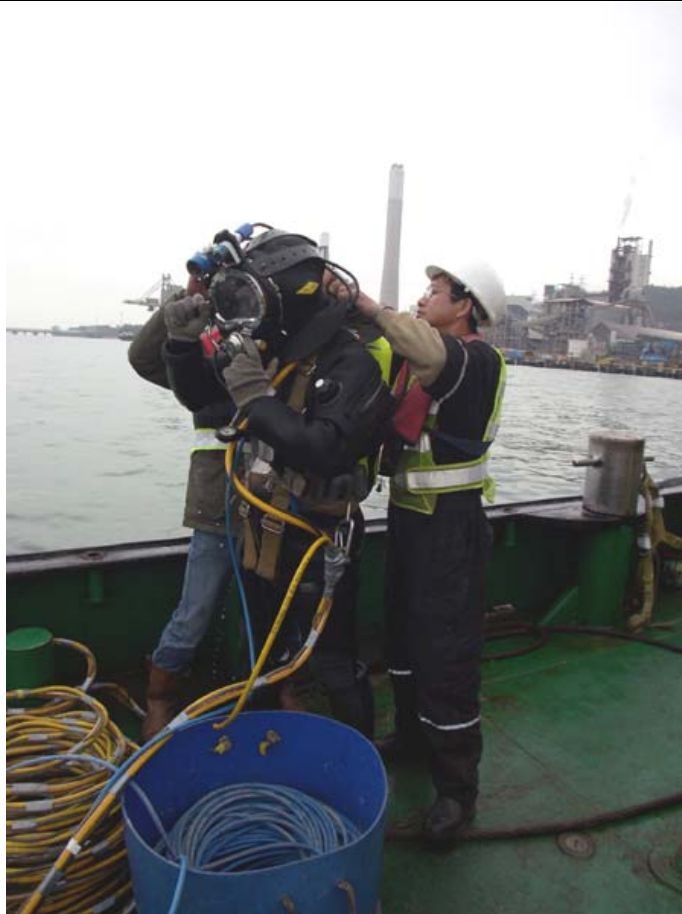
*Figure 3.8 Diver Being Prepared for Diving with the Full-face Mask and the Attached Camera and Lights*

The diver wore a full *Kirby Morgan* full-face mask which allowed for communications to the surface dive supervisor and the marine archaeologist (see *Figure 3.8*). A *Bowtech BP-CVIS II* compact video inspection system, incorporating a video camera and light mounted onto the diver's helmet, with a hard wire to a surface monitor for real-time display to the surface operator and marine archaeologist, was also utilised.

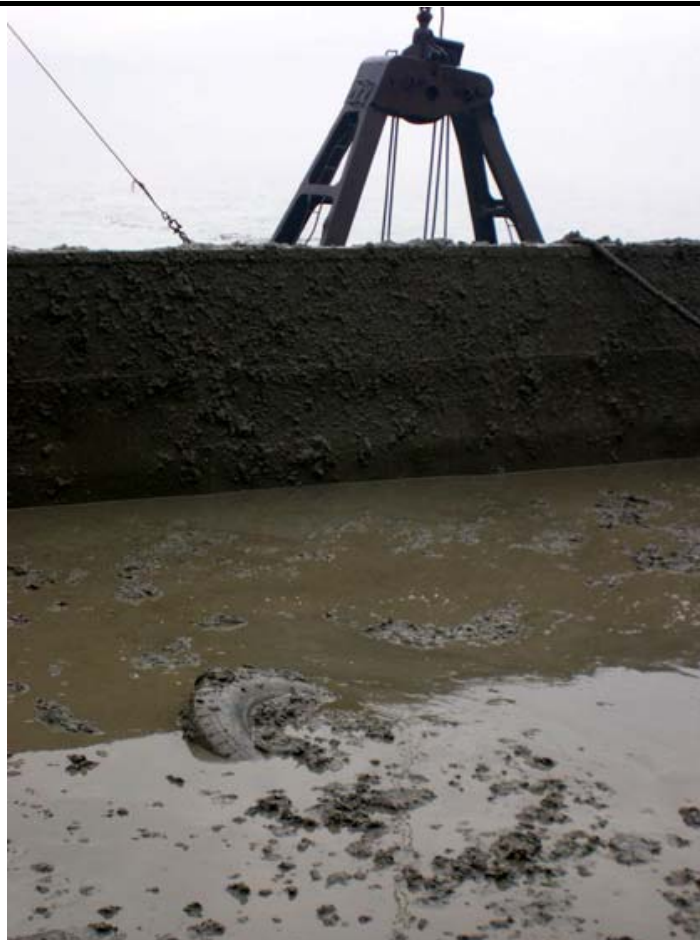
*Figure 4.1 Vehicle Tyre in the Dredge*

The material dredged consisted of the clayey, silt and mud sediments consistent with the marine sediments of the Hang Hau Formations. As the dredge approached the location of SS1, some small granite rocks and a vehicle tyre were recovered (see *Figures 4.1 and 4.2*). At the exact location of SS1, some larger granite rocks (c. 500kgm) and fishing netting were observed as being recovered and dumped into the barge. Apart from a modern bottle, no other material was found.

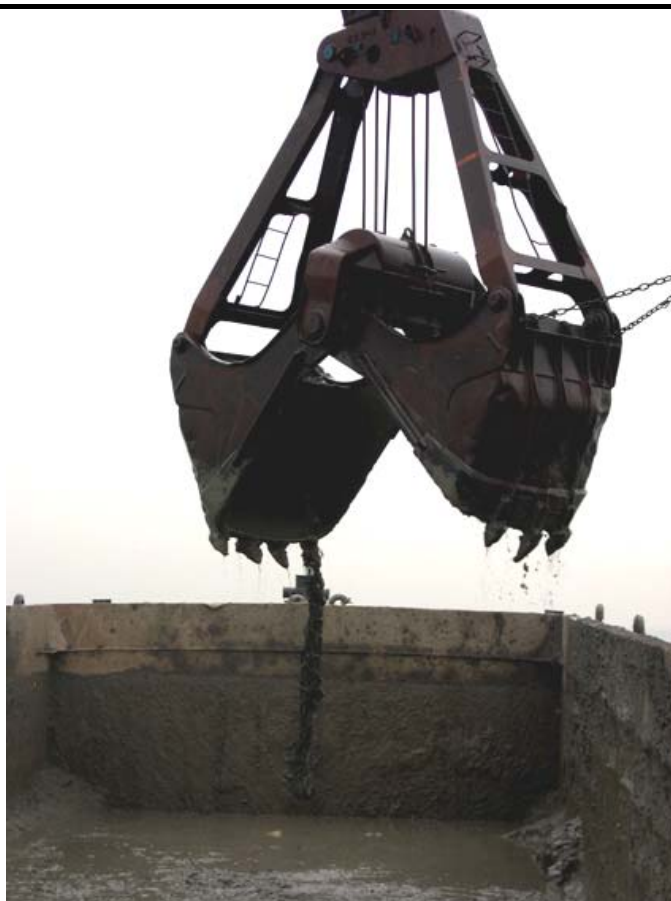
*Figure 4.3 A Fishing Net Hanging from the Bucket*

Again, the material dredged consisted of the clayey, silt and mud sediments consistent with the marine sediments of the Hang Hau Formations. As the dredge approached the location of SS2 (5-7 metres away), and at SS2, some very small amounts of refuse were recovered (plastic sheeting), in addition to a vehicle tyre, small pieces of wire cable, a few granite rocks and a fishing net (see *Figure 4.3*). No other material was found.

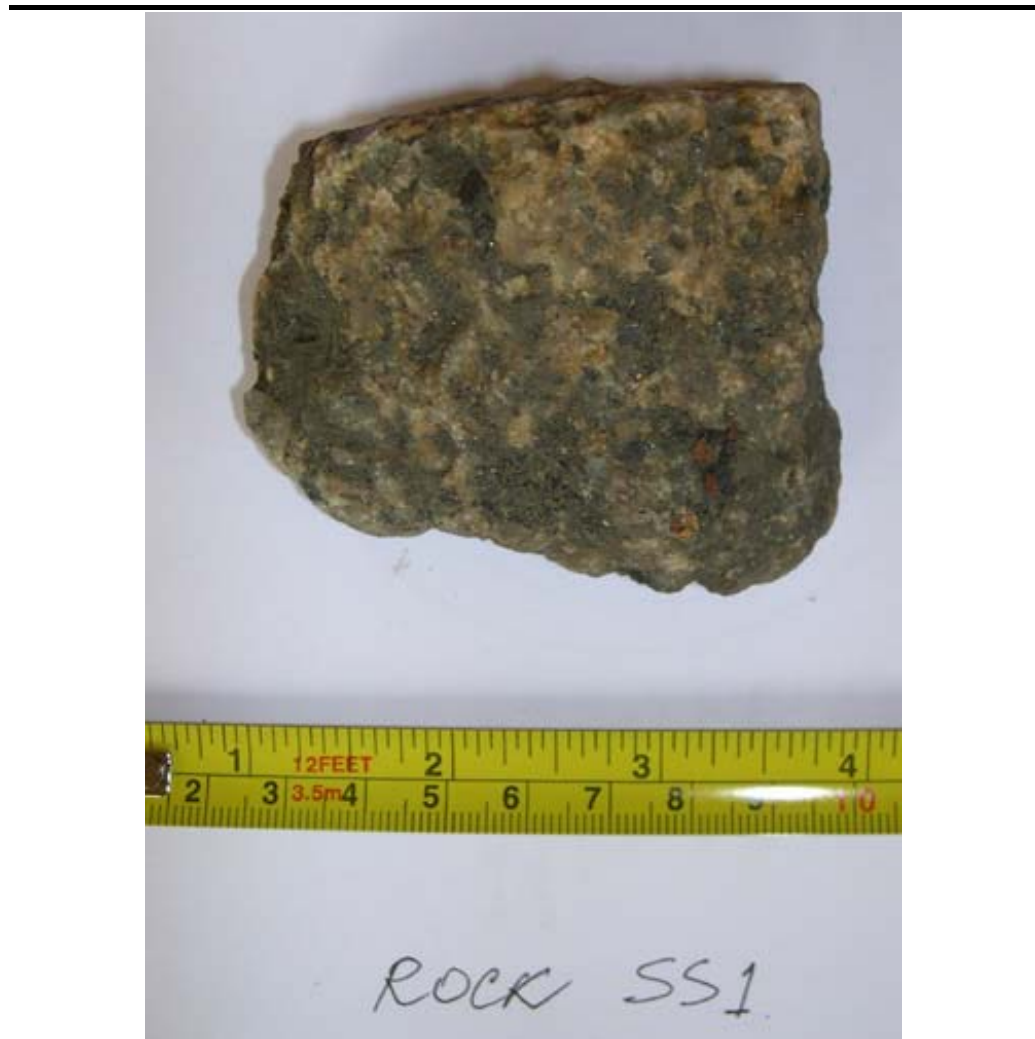
**Figure 4.4** *Small Granite Rock from SS1*

A three metre scattering of small granite rocks were encountered during the first dive. During the second dive, a random scatter of small granite rocks was encountered; one was recovered for photography (see *Figure 4.4*). No other material was found. The divers reported nil visibility although the underwater camera with the aid of a light allowed an occasional glimpse of the seabed to be seen from about 30 cm away. No objects in addition to what the diver reported were observed on the video.

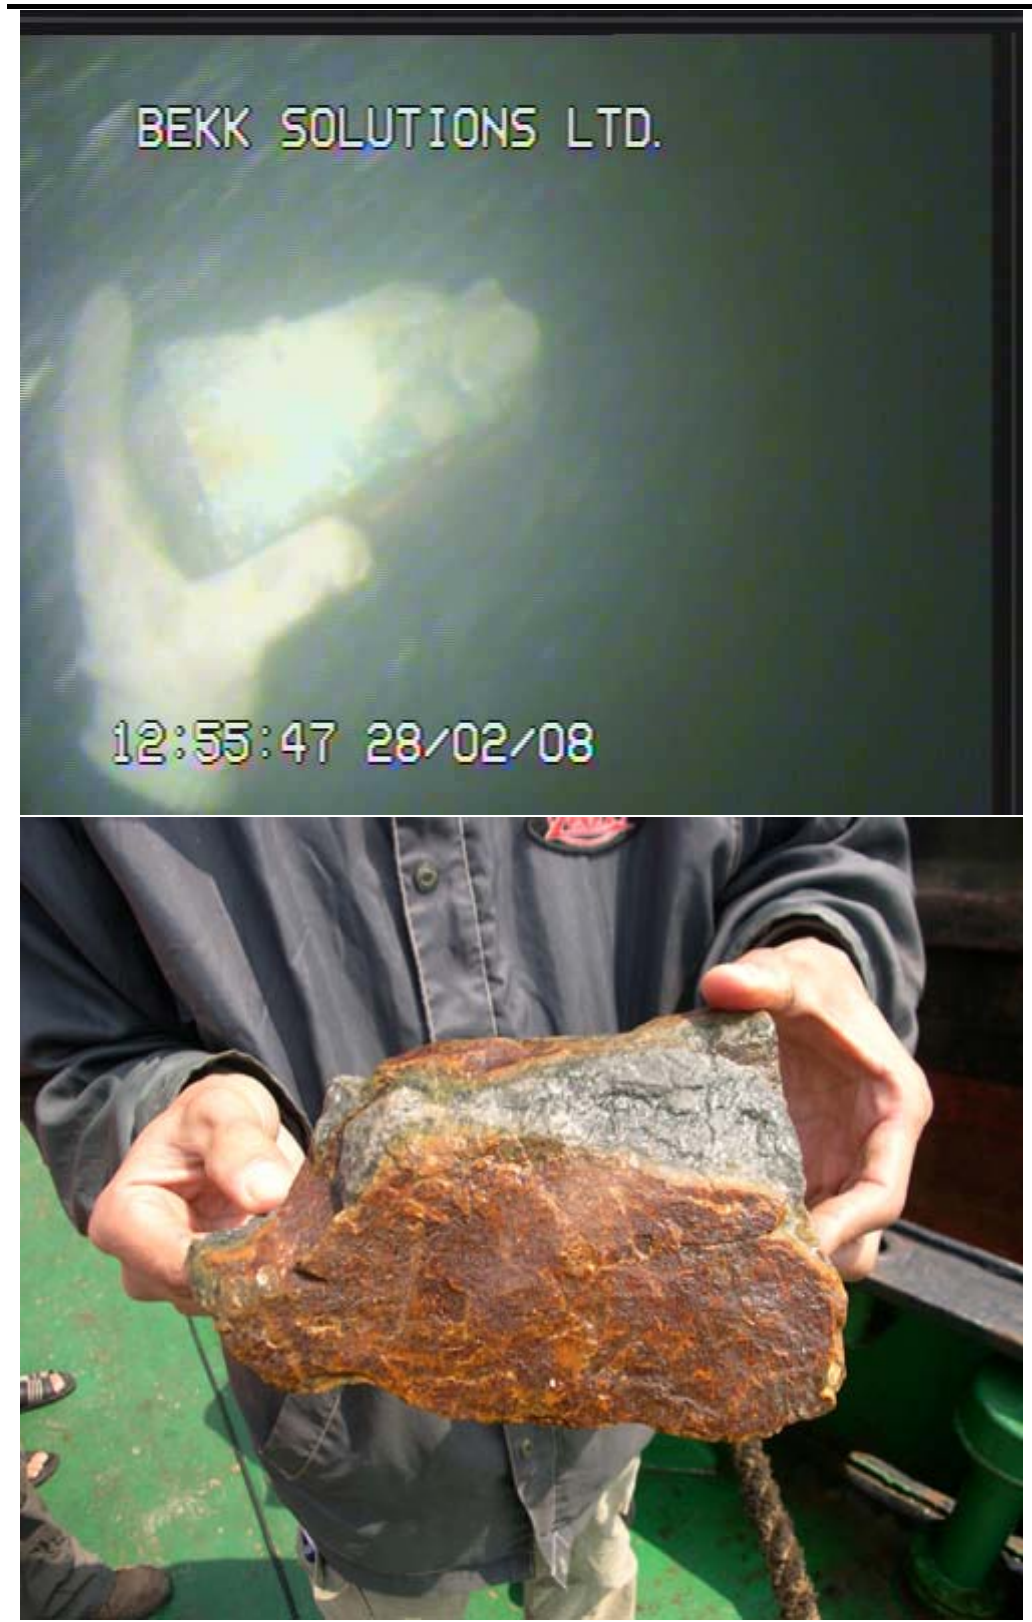
Figure 4.5 Diver Holding Feldspar Rock at SS2 and a Small Feldspar Rock from SS2

During the second dive, a swath of seabed 25 metres east x 20 north/south of the anomaly was surveyed. A few shells and 2-3 small feldspar rocks were observed through the underwater video, one was recovered for photography (see *Figures 4.5*). While the divers reported nil visibility, the camera provided for a reasonable picture of the seabed from 30cm above and clearer to that observed in SS1. No objects in addition to what the diver reported were observed on the video.

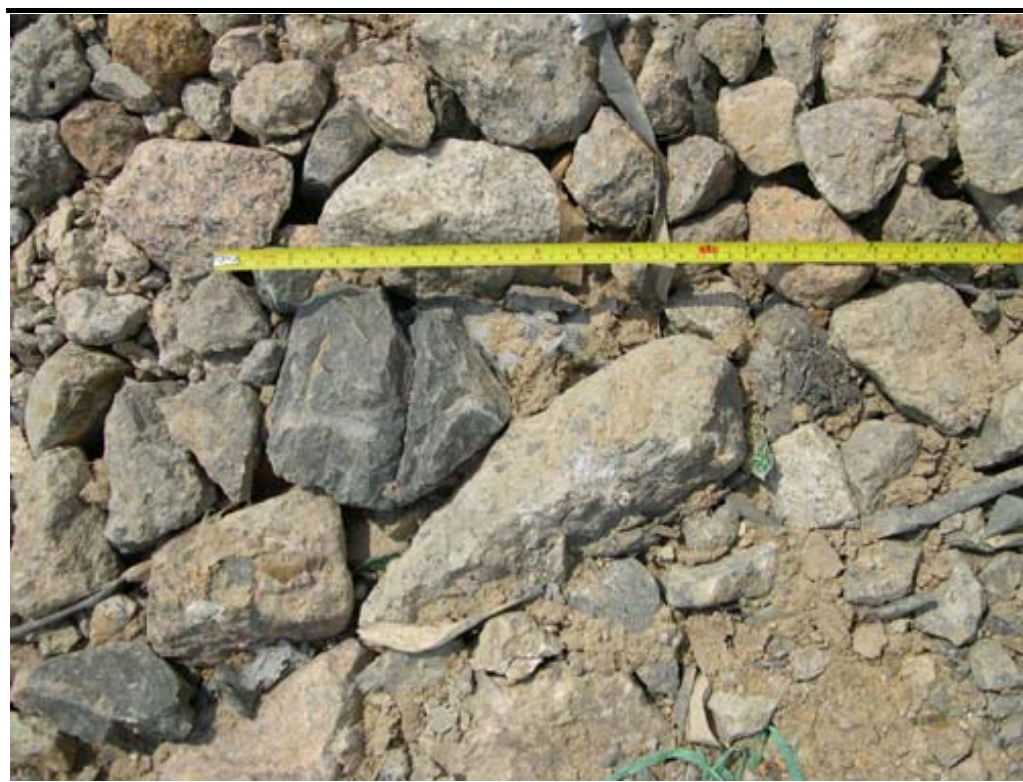
**Figure 5.1** *Rocks Similar to that Found at SS1 and SS2 in the Current Landfill adjacent to the PAFF Fuel Tanks*

The material observed during the dredging and dive surveys in the vicinity of the SS1 and SS2 anomalies has no cultural heritage significance. No archaeological material was observed during the dredging in either area. What was observed included a small number of rocks, fishing nets and vehicle tyres. The diver surveys, conducted at the depths that exposed the anomalies, failed to locate any material other than a small number of granite and feldspar rocks. These same rocks can be found as land fill in the yard with the PAFF tanks (see *Figure 5.1*)

It is concluded that the anomalies are associated with the contemporary use of Urmston Road as a busy seaway and the activities of the adjacent factories, power station, PAFF and reclamation material collection area.

No mitigation measures need to be put in place by the PAFF project in regard to the anomalies SS1 and SS2 are of no cultural heritage significance.
