Permanent Aviation Fuel Facility (EP-262/2007/B)

Twelfth Quarterly Environmental Monitoring and Audit Report – October 2009 to December 2009

26 January 2010

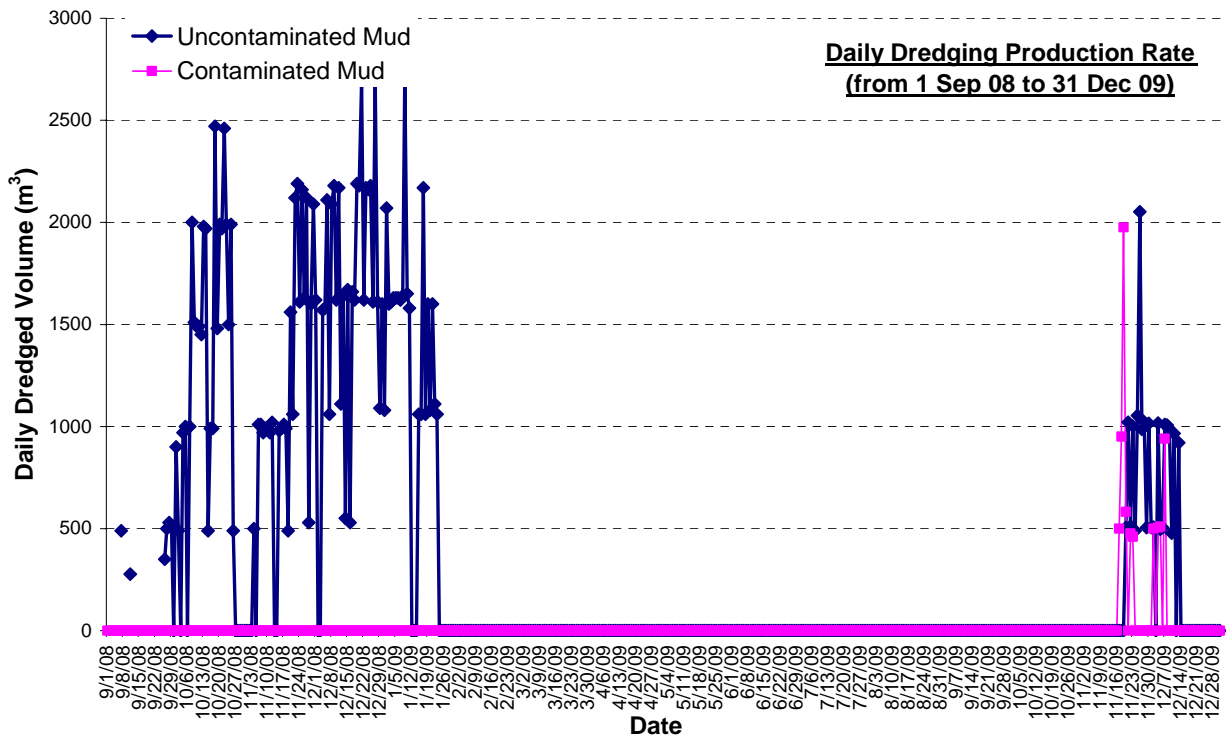
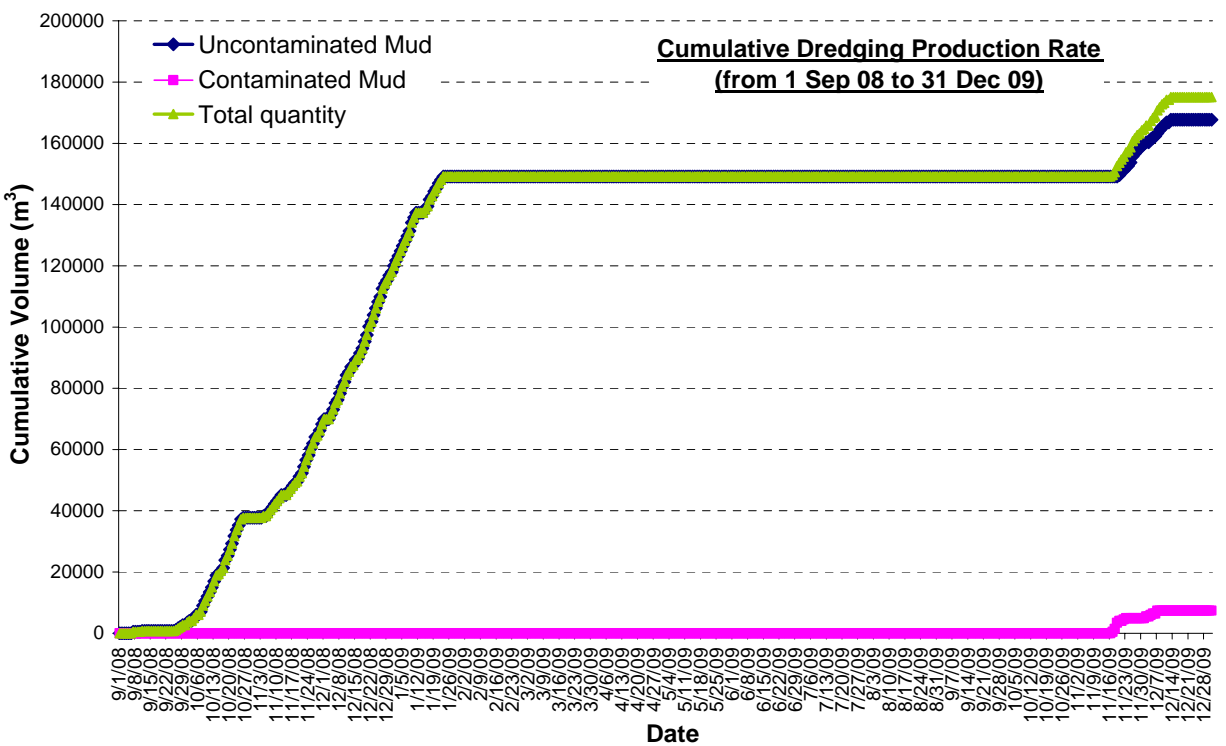
Figure 2.1 Daily and cumulative volumes (m³) of excavated materials (both contaminated and uncontaminated mud) from 1 September 2008 to 31 December 2009.

A summary of the major works undertaken in this reporting period is shown in *Table 2.1*. Initial marine dredging operations were completed on 23 January 2009. Due to pipeline repairs, dredging works were resumed on 13 November 2009 and completed on 11 December 2009. *Table 2.2* presents the cumulative quantity of excavated materials during marine dredging operations. Daily and cumulative dredging production rates between September 2008 and December 2009 are illustrated in *Figure 2.1*.

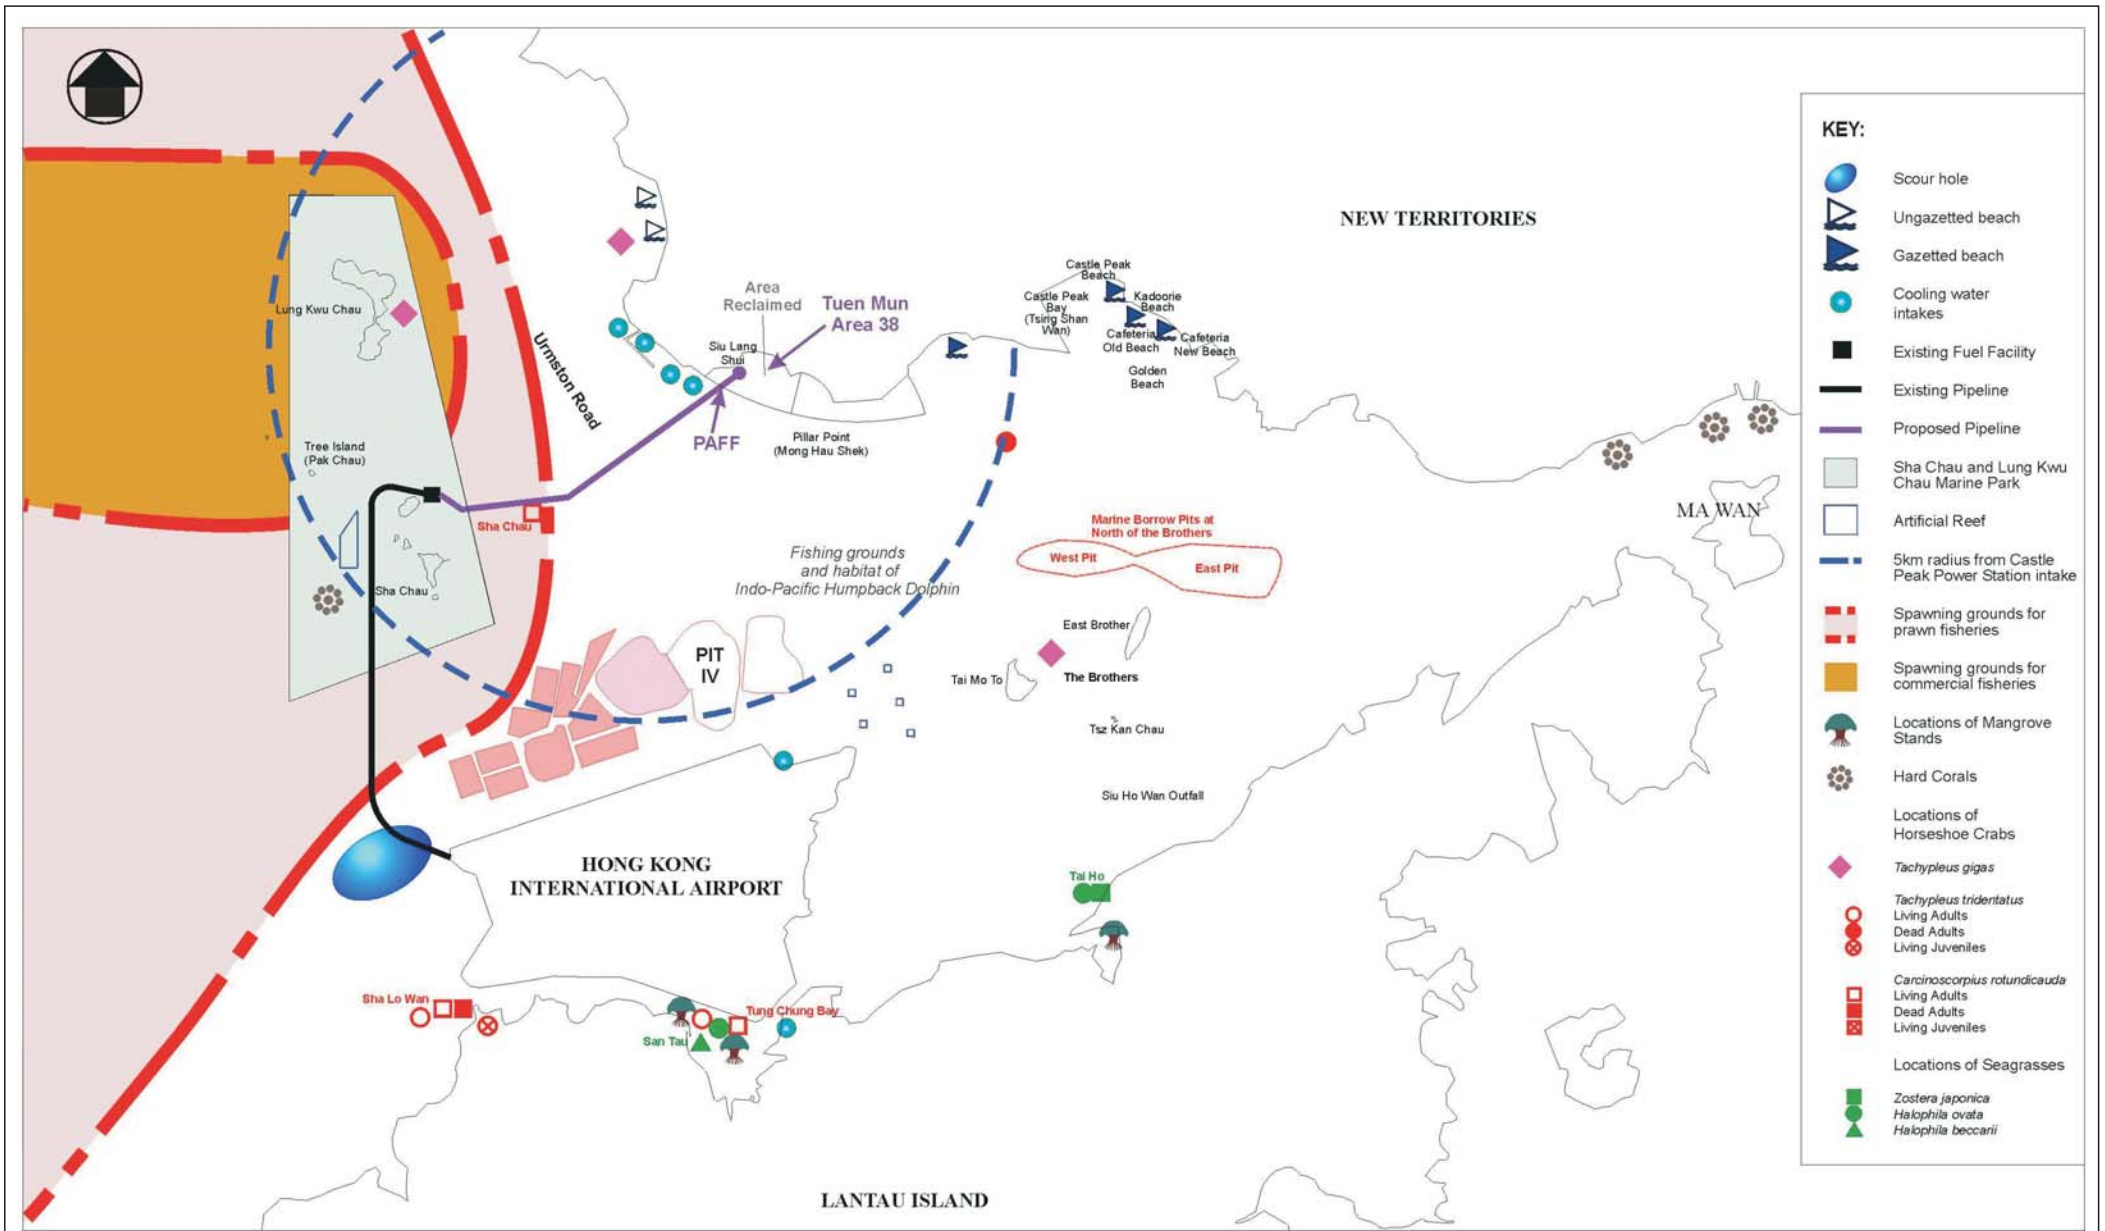
Annex B

Water Quality and Ecological Sensitive Receivers
